**STATE OF TENNESSEE  
DEPARTMENT OF TRANSPORTATION  
ENVIRONMENTAL DIVISION  
SUITE 900 - JAMES K. POLK BUILDING  
505 DEADERICK STREET  
NASHVILLE, TENNESSEE 37243-0334**

**MEMORANDUM**

Subject: ENVIRONMENTAL BOUNDARIES AND MITIGATION DESIGN FOR:  
Maury County, SIA serving Project Shotgun  
PIN Number: 121394.00 P. E. Number: 60019-1208-04

An ecological evaluation of the subject project has been conducted with the following results:

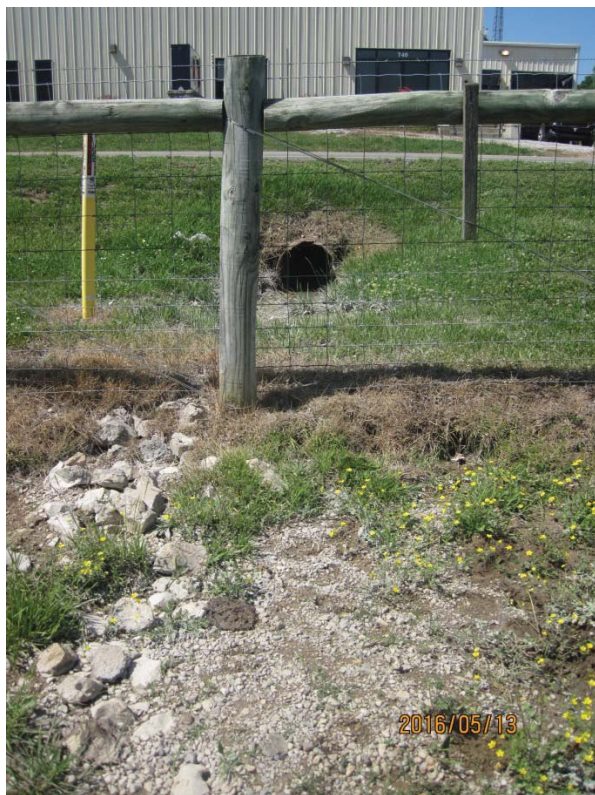
There is one stream, an unnamed tributary to Carter's Creek (STR-1), one WWC/EPH and one wetland. Forms and photos are included in this report.

**Notes :** This is a wet weather conveyance/ephemeral stream.

Photo 1: WWC-1/EPH-1 facing up gradient (north) towards Duplex Rd.

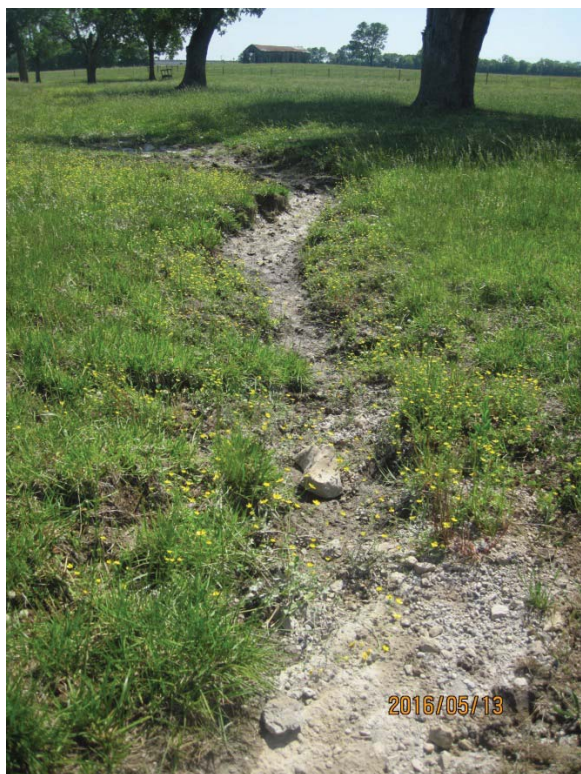
Photo 2: WWC-1/EPH-1 facing down gradient (south).

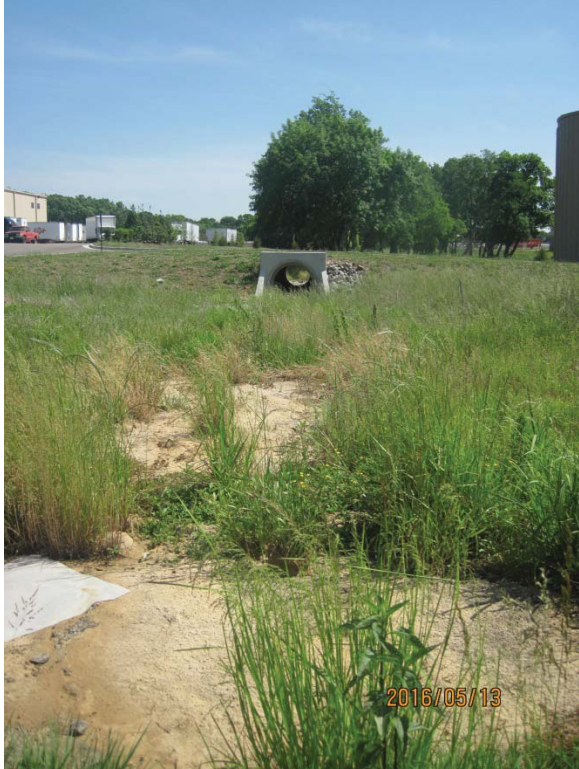
| <b>13-Notes</b> | <p>Stream has no flow at road crossing. There has been considerable modification (filling of channel) in the portion of the stream that flows through the industrial property near the road crossing. There is no flow until approximately 200' south of the edge of pavement (SR-247) to the wooded area where the stream resumes normal characteristics. Older aerial maps show a continuous stream that is connected to the wetland.</p> | | | | | | | |

**Overall Hydrologic Determination =** Stream because of presence of fish.

Photo 3: STR-1, facing upstream (north) toward Duplex Rd. This section of stream has been filled in.

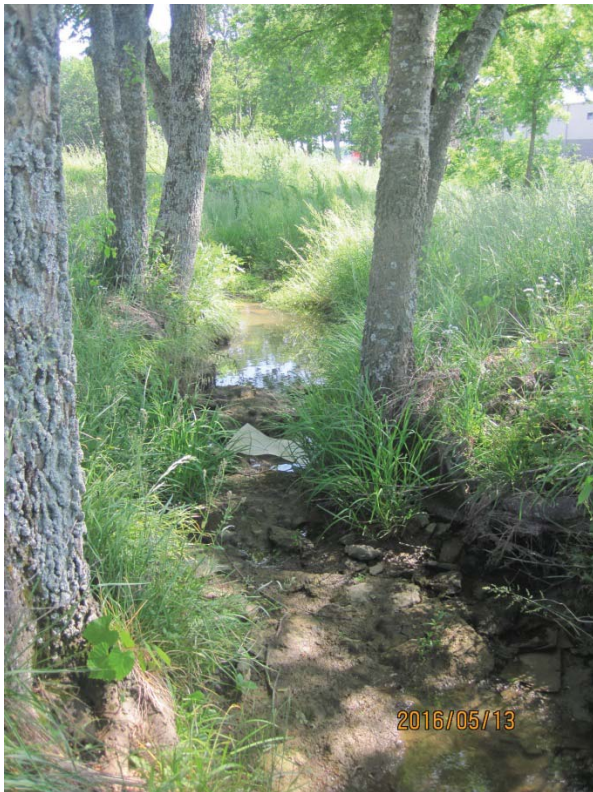
| -fish | Small centrarchids observed at culvert outlet (dead). | | | | | | | |

Photo 4: STR-1 facing downstream (south).

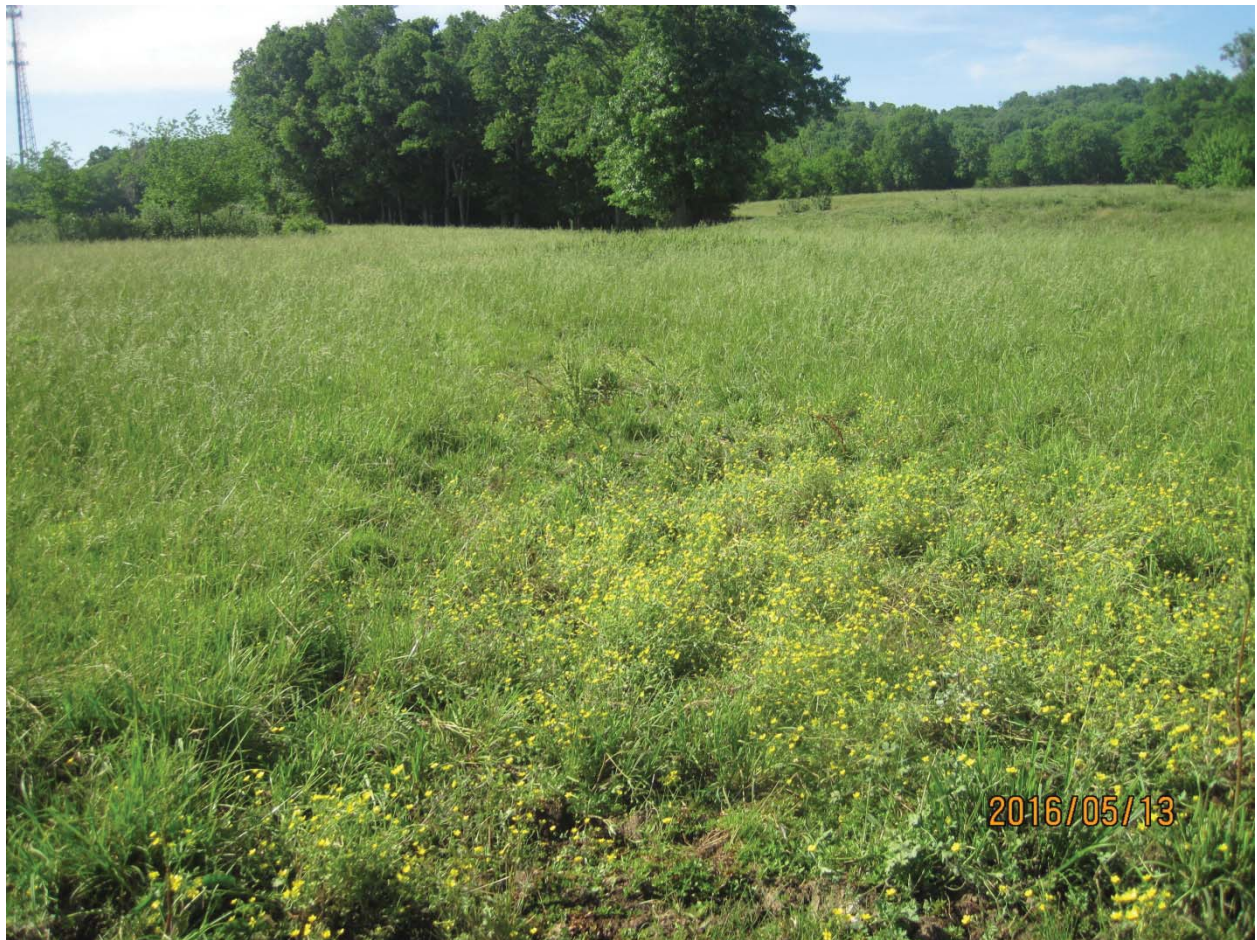
| Hydrophytic Vegetation Present? Yes <input checked="" type="checkbox"/> No _____<br>Hydric Soil Present? Yes <input checked="" type="checkbox"/> No _____<br>Wetland Hydrology Present? Yes <input checked="" type="checkbox"/> No _____ | Is the Sampled Area within a Wetland? Yes <input checked="" type="checkbox"/> No _____ |
| Remarks:<br>Photos: _____<br>Buffer (ft.): <u>50+' (mostly grass &amp; herbaceous veg)</u><br>Approximate Size (ac.): <u>0.9 total- most is off ROW</u><br>Portion Affected (permanent) (ac.): <u>0.12</u><br>Portion Affected (temporary) (ac.): <u>0.12</u> | Confirmation (by, date): _____<br>Mitigation (to be included in design): _____<br>Notes: _____ |

Photo 5: WTL-1 facing north.
